Inspection, Assessment, and Repair of Heavy Wall Reactor Vessels in High-temperature High-pressure Hydrogen Service

API TECHNICAL REPORT 934-H
FIRST EDITION, MAY 2022

**American
Petroleum
Institute**

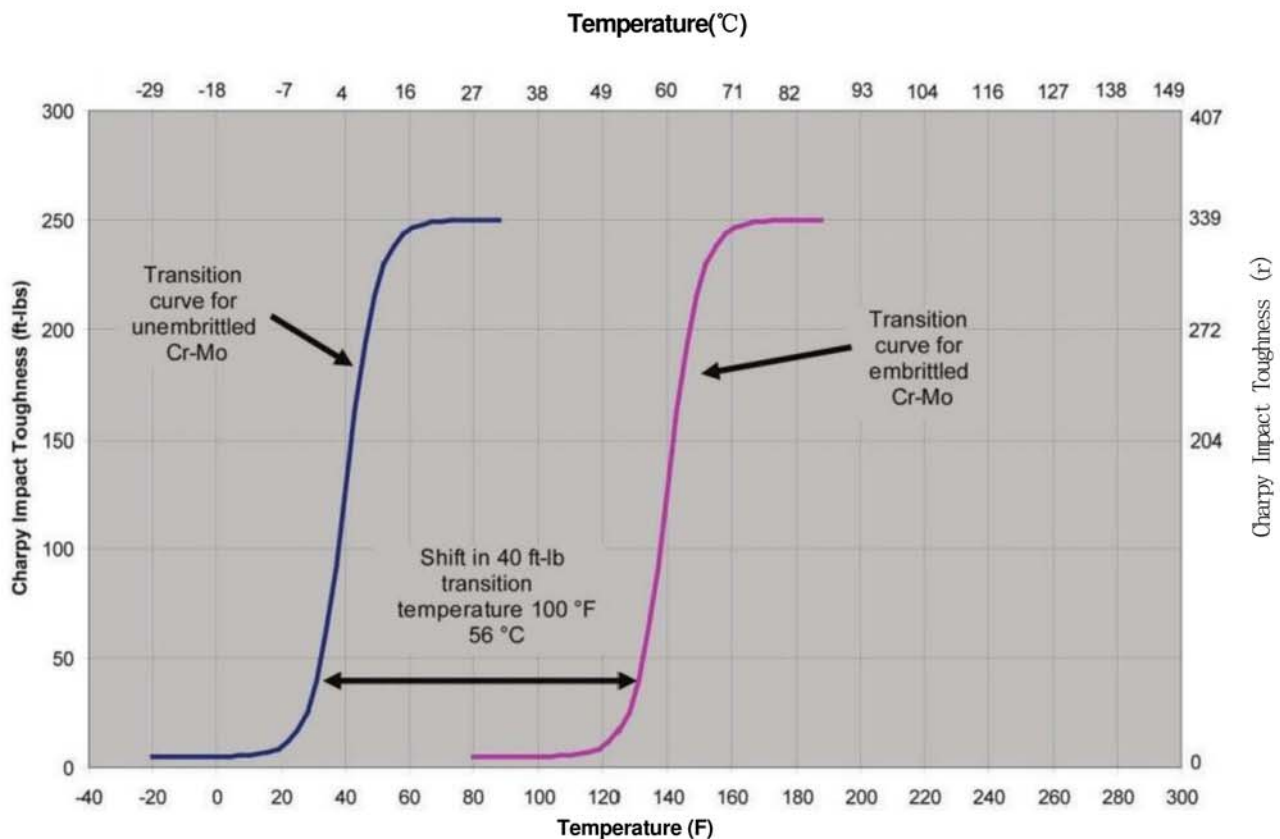
Figure 1-Temper Embrittlement Results in an Upward Shift of the Transition Temperature for Brittle Fracture

Theoretically, the effects of temper embrittlement can be reversed by a high-temperature heat treatment followed by rapid cooling. A de-embrittling heat treatment involves holding at 600-625°C (1100-1150°F) for two hours minimum, followed by water quenching or fast cooling as outlined in API 571 and API Publication 959. However, there are no reported cases where a de-embrittling heat treatment has been performed prior to weld repairs on Cr-Mo equipment affected by temper embrittlement. This is likely to be because it is impractical to achieve the required fast cooling/water quenching from the de-embrittling heat treatment temperature on a reactor without generating large thermal stresses in the area being cooled. As a result, other steps to minimize the risks from embrittlement have been implemented during repairs, such as bake-outs, preheat, and more, as discussed in other sections of this API 934-H document.

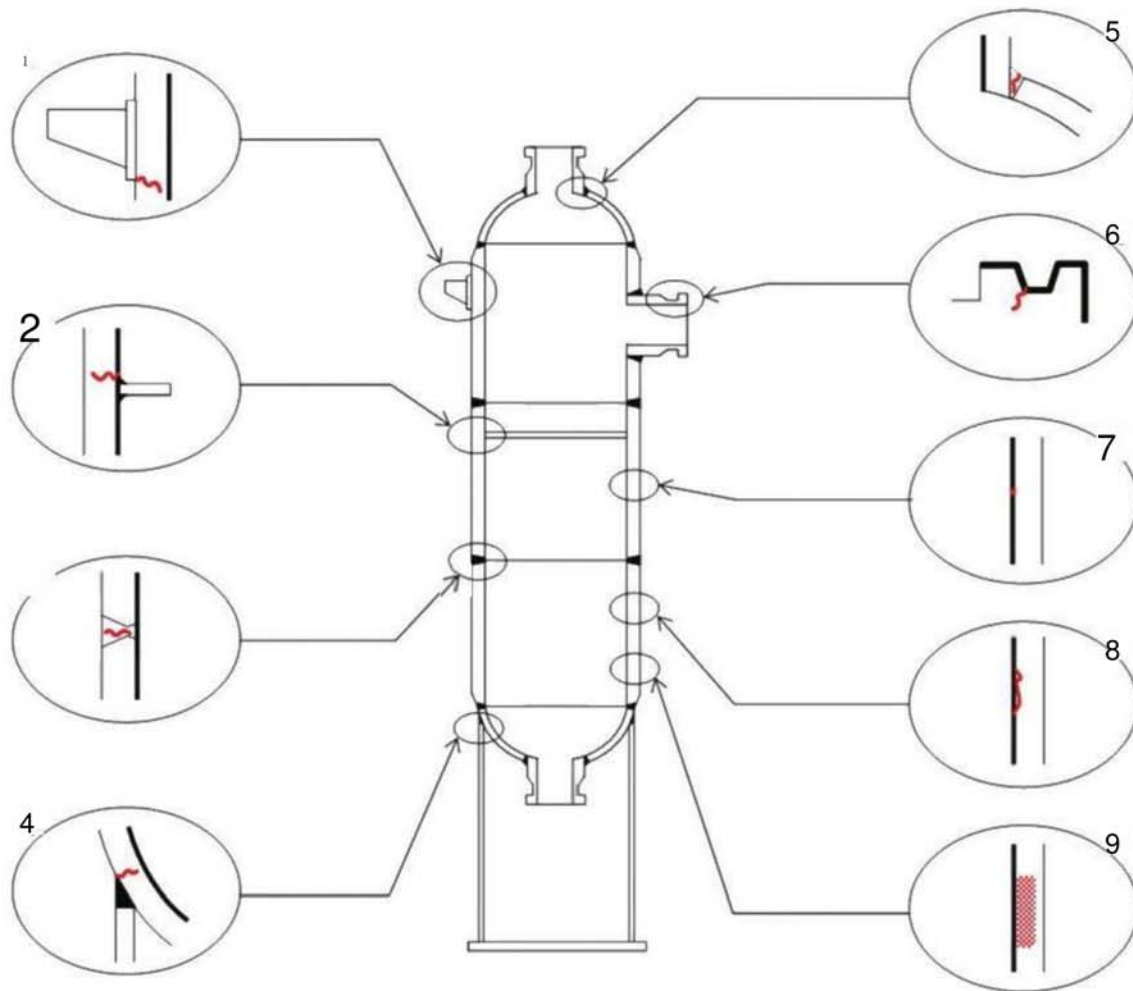
1. Cracks at external attachment welds (See 6.2)
2. Cracks at internal attachment welds (See 6.3)
3. Cracks at longitudinal and circumferential weld seams (See 6.4)
4. Cracks at skirt attachment welds (See 6.5)
5. Cracks at nozzle attachment welds (See 6.6)
6. Cracks at ring joint grooves (See 6.8)
7. Cracks in weld overlay cladding (See 6.9)
8. Cracks at the interface between the cladding and base metal (See 6.10)
9. Damage in the Cr-Mo base metal (See 6.12)

Figure 2—Areas Where Damage May Occur in Heavy Wall Reactor Vessels

There are several types of flaws that can occur in heavy wall reactor vessels, mostly occurring in older generation vessels. These are illustrated in Figure 2 (published in WRC 566) and further described in 6.2 to 6.12. These flaws can result from the combined effects of the damage mechanisms described in Section 5.

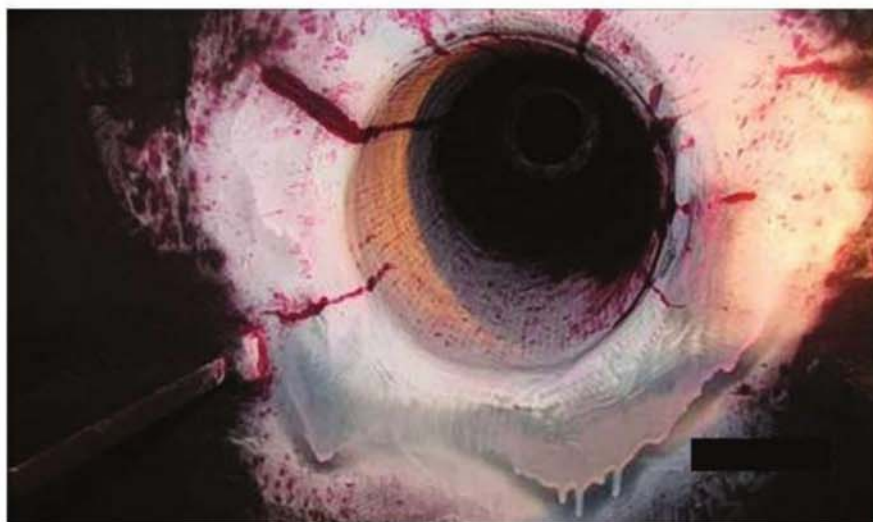
Figure 5—Cracking Observed at Quench Nozzle in a Heavy Wall Reactor Vessel

In a quench nozzle without an internal distributor pipe inside the nozzle, the nozzle wall is exposed directly to cool hydrogen gas. In this situation, cracking initiates at the corner where the end of the set-in nozzle meets the ID surface of the reactor. It then propagates axially along the inside surface of the nozzle. This type of cracking is more common in reactor vessels with internal SS cladding due to the high thermal coefficient of expansion for 300 series SS compared with the underlying Cr-Mo steel. Examination for this cracking is typically performed from the inside surface of the reactor during a turnaround using PT for clad or overlaid vessels and MT for vessels without cladding. An example of thermal stress cracking observed on the inside surface of a vessel at a quench nozzle in a heavy wall reactor vessel is shown in Figure 5.

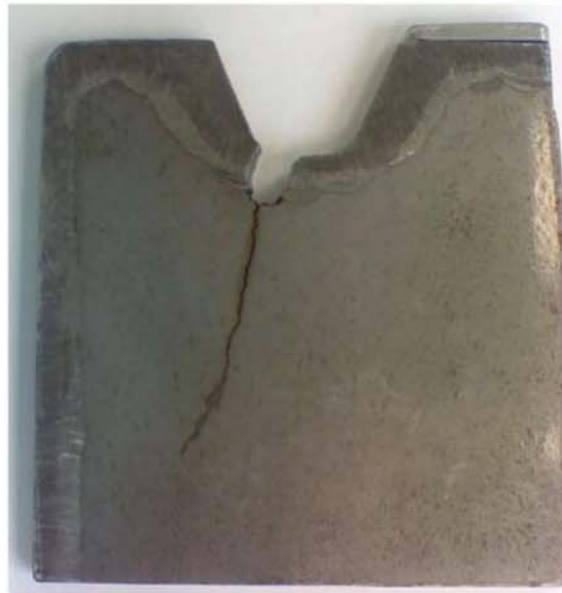
Figure 7—Cross Section of an RTJ Flange with Cracking from the Inner Corner that Extended Deeply into the Cr-Mo Base Metal

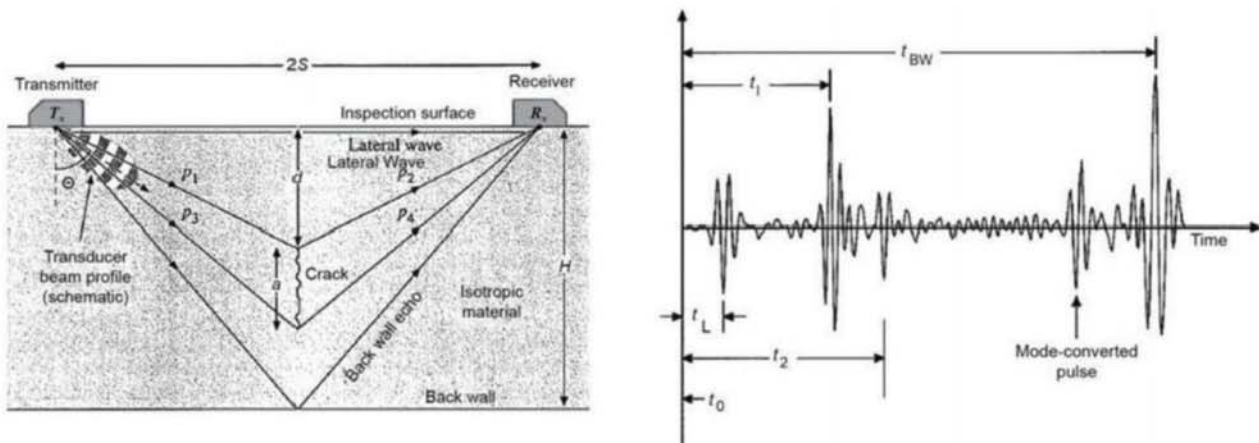
Figure 11—Typical Transducer Arrangement for TOFD Inspection of Welds[29]

The basic arrangement of the twin probe technique for TOFD is illustrated in Figure 11. One probe (transducer Tx) transmits ultrasound and the other (transducer Rx) acts as the receiver. Probes with beams as diverging as possible are used to increase the beam coverage. The beam coverage is usually very close to the separation between probes, as illustrated in Figure 11, which is twice the probe-center separation. This separation typically can cover not only the weld cross section but also the heat-affected zone and part of the base metal. 29

Signals obtained from the propagation waves, shown in Figure 11 on a two-dimensional image, commonly known as a B-scan, are obtained in real time, as the two transducers move on the surface of the component. A typical image is shown in Figure 12, where the horizontal axis represents the displacement of the transducers on the inspection surface. The vertical axis represents the times of arrival of the signals coming from the lateral wave and the reflected and diffracted waves for the observed discontinuities/flaws in the material, and the back-wall reflection.

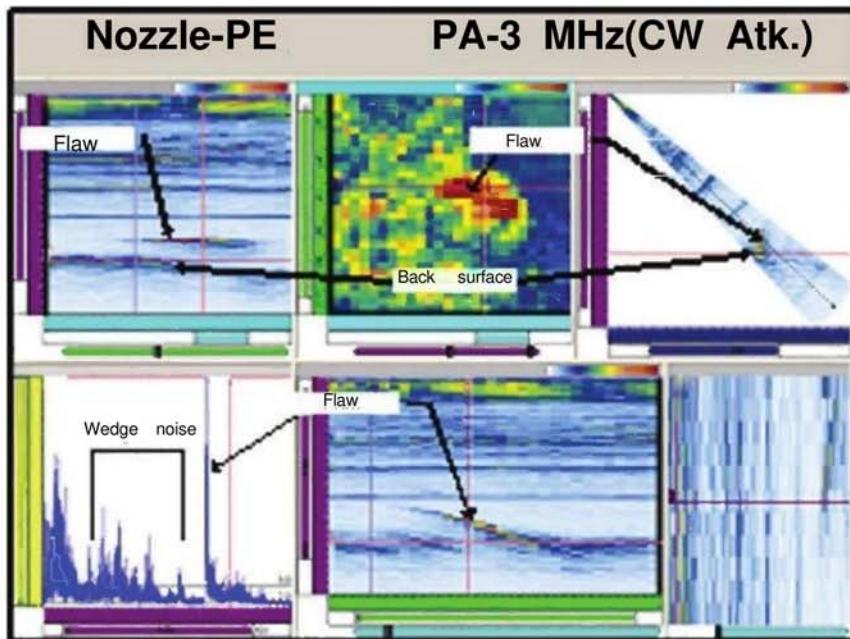
Figure 17—PAUT A-B-C-D-S-scan Imaging of Individual Crack-like Indication in a Nozzle Weld

The assessment results of multiple UT techniques capabilities and guidance on determination of appropriate techniques for inspections of reactor nozzle welds are presented in EWI, ASNT, and International Institute of Welding (IIW) publications.^{29,30} Ultrasonic modeling and simulation were used with NDE engineering as an effective way of determining that the internal flaws or damage in high risk geometries of heavy walled hydroprocessing reactors can be theoretically located and sized. After modeling and simulation work was completed, the best ultrasonic techniques were selected for experimental validation on specific damage in fabricated mockups with real flaws. Figure 17 shows an example PAUT of a typical nozzle perpendicular to the shell weld and imaging of a surface-breaking crack propagating beyond the cladding interface.

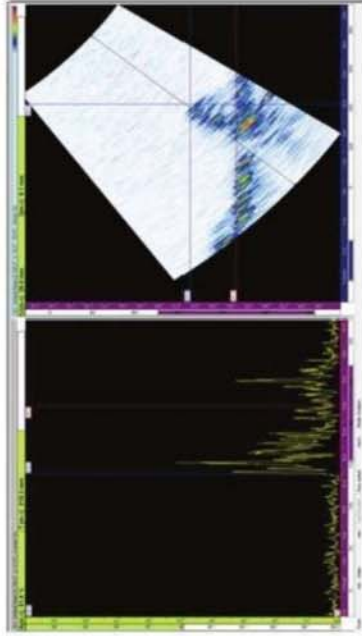
a) PAUT S-scan imaging of individual crack-like indication.

b) PAUTA and S-scan imaging of individual crack-like indications.

c) PAUT D-scan imaging of multiple crack-like indications.

d) A and D-scan TOFD imaging of multiple crack-like indications.

Figure 19-PAUT and TOFD Inspections of Typical Catalyst Bed Support Weld Geometry#2 and Imaging of Surface-Breaking Cracks Propagating Beyond the Cladding Interface

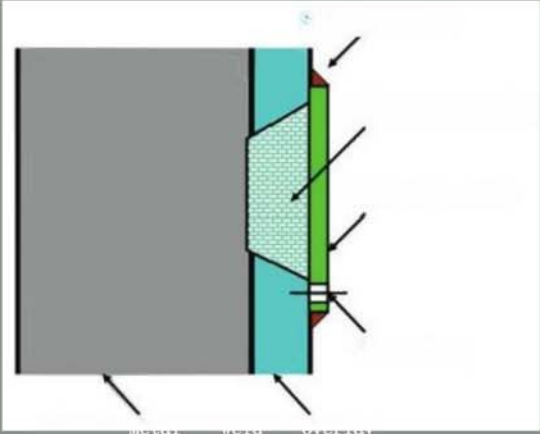
4	Inspection	PT for fillet weld				
Sketch of Repair

Bead-on Test				
		UT				
		Excavation of Cracks				
		PT				
		Fill of Refractory				
		SS Fillet Weld of Patch Plate				
		PT of Fillet Weld				
Reference:	8-1

Title		Repair of Gasket Groove			
Type of Reactor	Hydrocracking reactor	DT	432°C		Owner
		DP	146 kg/cm ² G		
Operation History	Operated for 22 years	Base Metal	21/4Cr-1Mo (Thk: ---mm)		
		WOL/Clad	Type 309/347 (Thk: 5.3 mm)		
Type of Flaws and Locations	Crack by hydrogen&sigma phase embrittlement in RTJ gasket groove of top 18-in.-(I.D.) manhole nozzle				
Note	---

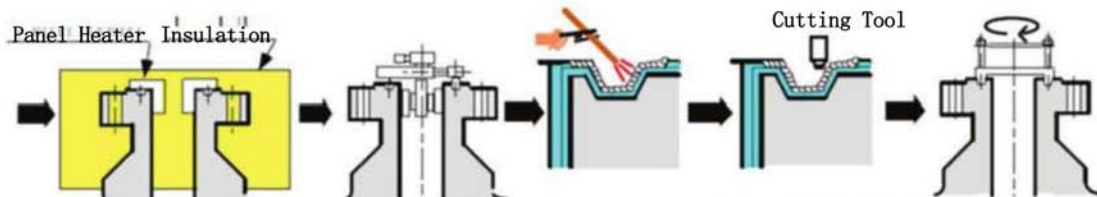
Sketch of Repair

Detection of Crack in Removal of Crack by Preheat, Cr-Mo Weld, Preheat, WOL of Tp. 309+308L, gasket Groove by Machining or Grinder Grinding, NDE (MT) Grinding, NDE (PT)

Local PWHT Machining of Gasket Groove WOL of Tp. 347L Finish machining of Final layer Finish by lapping of Gasket Groove, NDE (DT&PT)

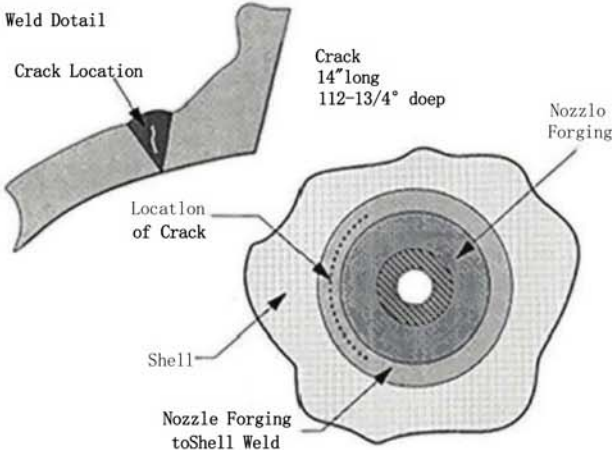
<p>Weld Detail</p> <p>Crack Location</p> <p>Location of Crack</p> <p>Crack 14" long 1 1/4" deep</p> <p>Shell</p> <p>Nozzle Forging to Shell Weld</p> <p>Nozzle Forging</p>		<p style="text-align: center;">Case #1</p> <p style="text-align: center;">Ambient</p> <p style="text-align: center;">Weld prep</p> <p>12 hrs DHT 400 C, 2hrs</p> <p>16 hrs Weld base metal PT, UT</p> <p>18 hrs ISR, 610°C (full circumference), 5 hrs PT, UT Base Metal</p> <p>12 hrs Weld overlay PT overlay</p> <p>48 hrs PHWT 690 C (full circumference), 8 hrs</p> <p style="text-align: center;">Ambient</p> <p style="text-align: center;">RT</p> <p style="text-align: center;">Repair Details</p>			
Reference:		---

10	Inspection weld overlay	PT			
11	PWHT	690°C, full circumference, eight hours			
12	Inspection	PT, UT			
Sketch of Repair
